◆ On the banks of the Uck: the story of a Wealden hall house

Andrew Margetts

At the southern end of Uckfield High Street, on the northern bank of the River Uck, lies Grade II-listed Bridge Cottage. The building, which comprises one of the largest Wealden hall houses in the area, has recently been the subject of comprehensive restoration. Bridge Cottage was originally saved from demolition in the 1970s by Uckfield District Preservation Society. Once ownership was secured, repairs were carried out and excavations, led by Ian Brooker, undertaken. Brooker never succeeded in publishing the results and it was not until Archaeology South-East's involvement that the earlier excavations could be fully understood. The more recent archaeological work was undertaken in response to the latest renovations and this article reports on their results. They are significant in showing the development of an individual house plot from the late medieval to post-medieval period. They provide an important analysis of architectural expressions of status and display for a Wealden household of the yeoman class.

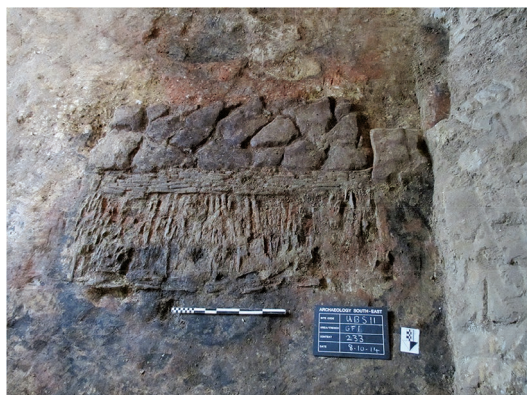
Fig. 8. Period 1 hearth (0.5m scale bar).

In places, the upper surface of these layers was discoloured through burning and, in the north-western part of Bridge Cottage's existing hall, a rectangular hearth comprising ferruginous Wealden flagstones, as well as ceramic and stone tiles laid on edge, was encountered (G1; Fig. 8).

Attempts to scientifically date the hearth proved inconclusive. However, its presence, together with the remains of a contemporary sandstone sill wall (G6) and twin post-holes [240] and [249], indicate something of the ground plan of the medieval building. The post-holes contained late 13th–14th-century pottery as well as slag, charcoal from a mix of species, sandstone fragments, mortar flecks, and burnt clay.

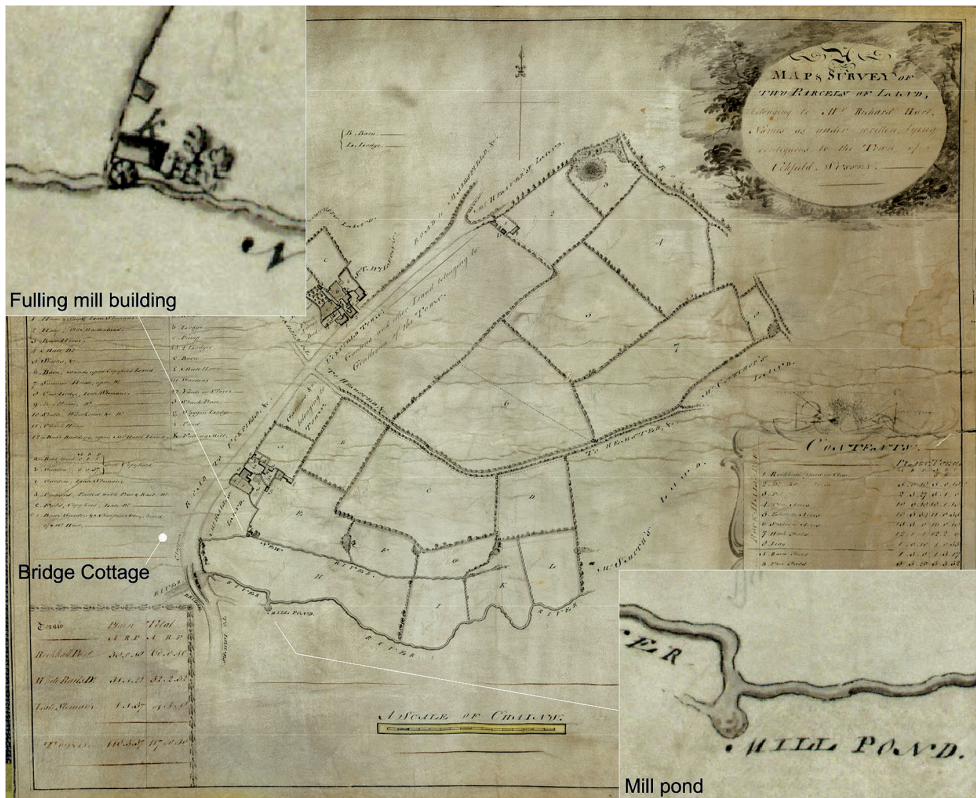
Fig. 9. Richard Hart's estate map of 1784 (ESRO ACC 3763) showing the location of the fulling mill.

A mill pond and fulling mill are shown close to the east of the site on Richard Hart's estate map of 1784 (Fig. 9) and a further fulling mill may be represented by a pond with an associated leat in a land parcel named Tom Fullers field on the 1841 tithe (Fig. 10; ESRO ACC 9558, land parcel 262). The presence of these water-powered industries is clear evidence that the River Uck was key to the settlement's medieval economy; however, its proximity has also been a source of heartbreak to the town.

It was the emergence of the important Wealden broadcloth industry, however, which was more concurrent with the construction of Bridge Cottage (*see Zell 1994; Flisher and Zell 2009*). The cloth industry was dependent on fulling mills, two of which are known to the east and west of the site (Figs 9 and 10).

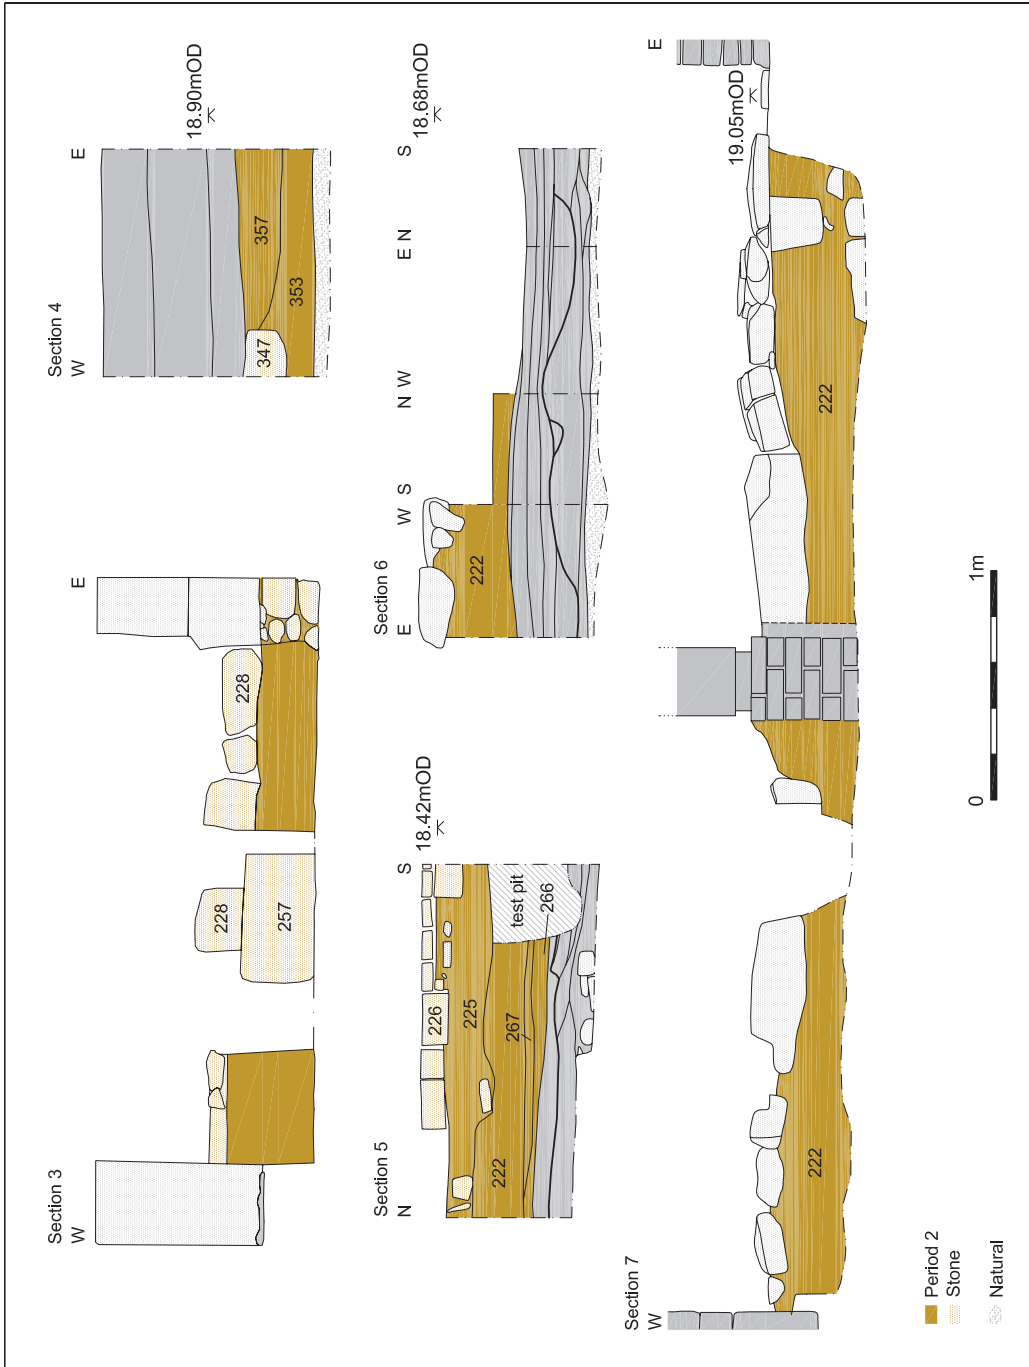
Fig. 12. Period 2 sections.

To the south of the high-end bay, the northern wall of the hall (G25; [228], [257]; Fig. 12), as well as the western wall of the aisle were encountered (G12). Some masonry blocks (G17) found near to the hall's northern wall almost certainly relate to props used to support the sole plate during the erection of the frame.

In the service bay, the eastern (G10) and southern wall (G13) were found, together with the western wall of the rear range (G18; [347]; Fig. 12) and its clay floor (G49; [357]; Fig. 12).

This underpinning gave the stratigraphic impression that most of the walls had been constructed before the floor-raising event. However, it was far more clear that the eastern wall of the hall (G11; [226]; Fig. 12), its rammed clay floor, and the

The floor-raising deposit comprised a layer of light yellow-brown, silty clay up to 450mm thick (G19; [222], [225], [266], [267]; Fig. 12). It contained finds of slag, copper, animal bone, and iron nail fragments, as well as a sherd of tin-glazed plate (dated 1675–1750), early 18th-century pieces of clay tobacco pipe and slightly corroded fragments of green wine bottle. The latter three categories of find are all thought to be intrusive.

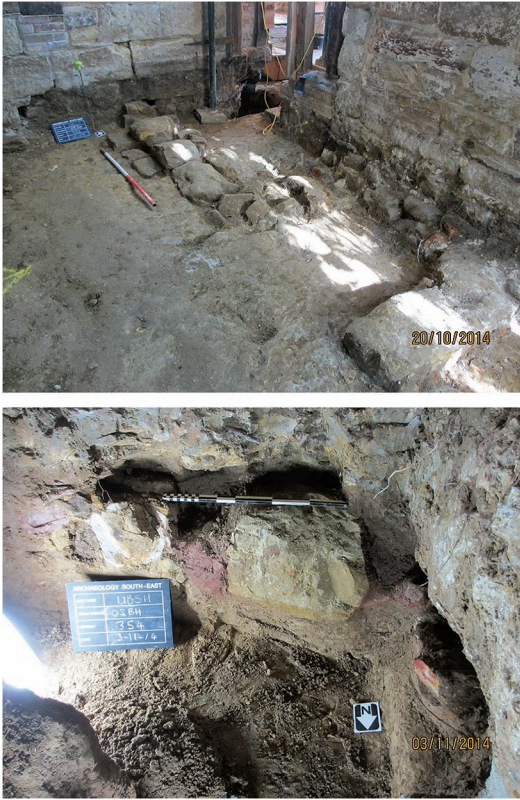
Fig. 13. Photos, Period 2. Top: junction of walls G12 and G20 looking north-east; bottom: part of G21 showing pink clay deposit (1.0m scale bar top; 0.5m scale bar bottom).

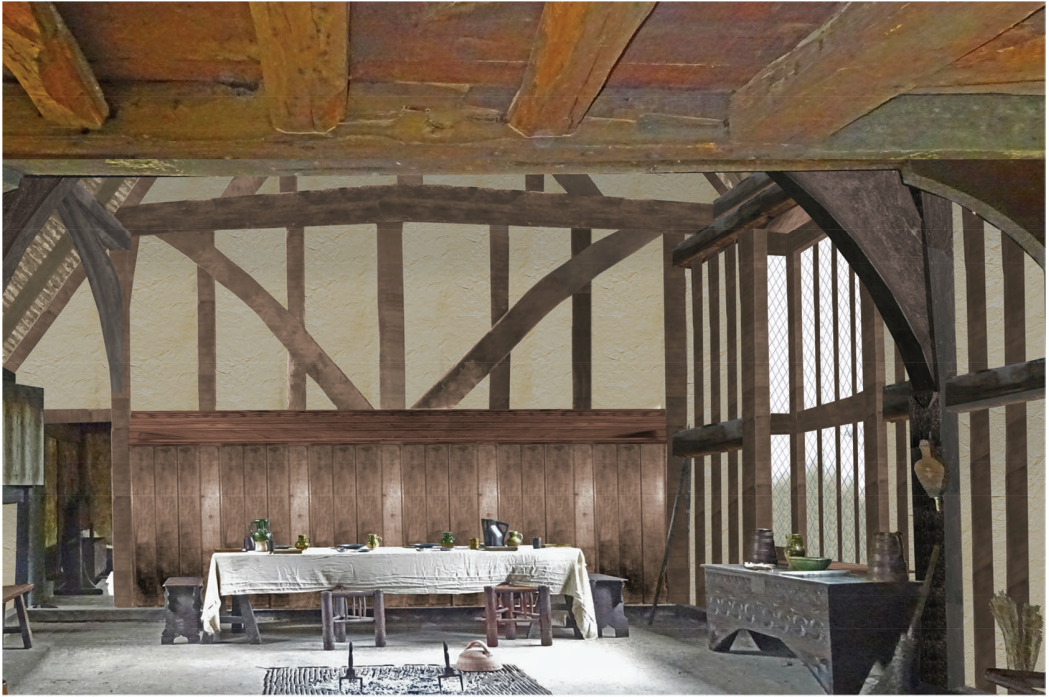
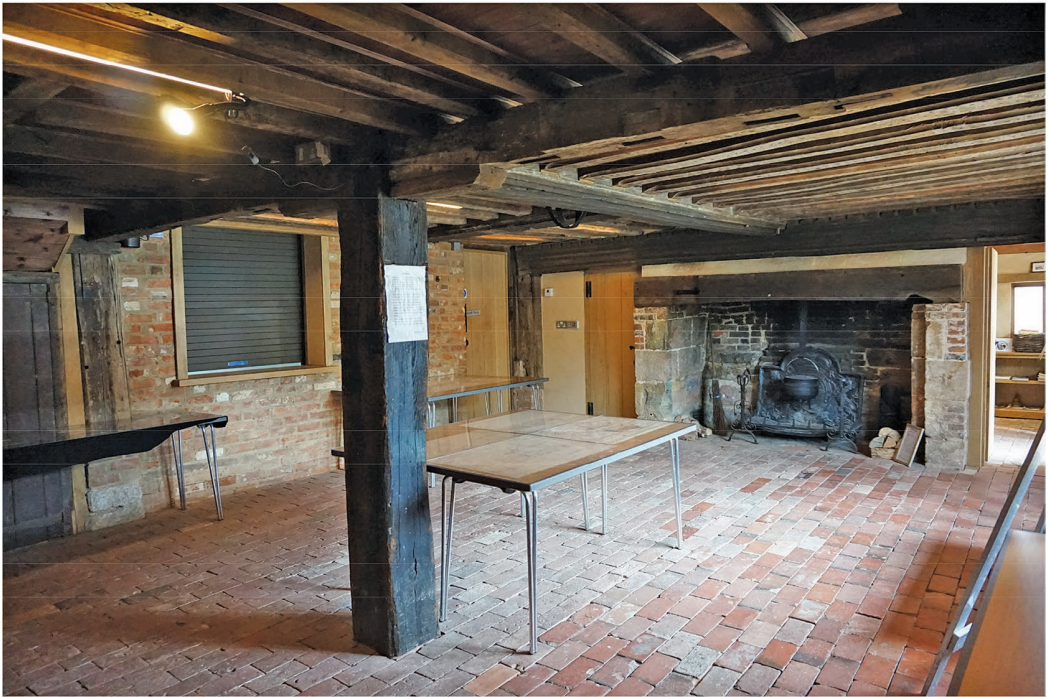
Fig. 15. Interior of Bridge Cottage during Period 2. Top: reconstruction looking towards the dais partition and high table (courtesy of David Martin); bottom: following restoration (with the floor and chimney inserted).

partition with its intricately carved dais beam and timber panelling (Fig. 15).

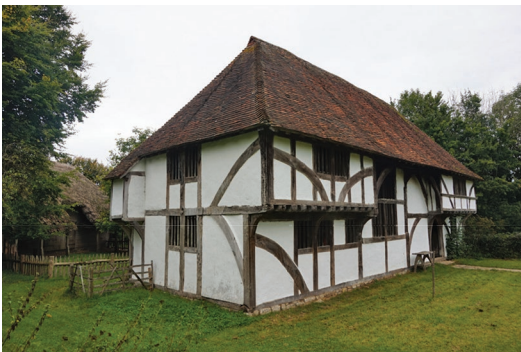
Fig. 16. The projecting garderobe (rear left corner) as reconstructed at Bayleaf, from Chiddingstone, Kent, now at the Weald and Downland Living Museum.

It is unclear whether the garderobe outshut extended down to ground level (Fig. 14) or was supported on brackets, as reconstructed in Bayleaf at the Weald and Downland Living Museum (*ibid.*, 17–18; Fig. 16).

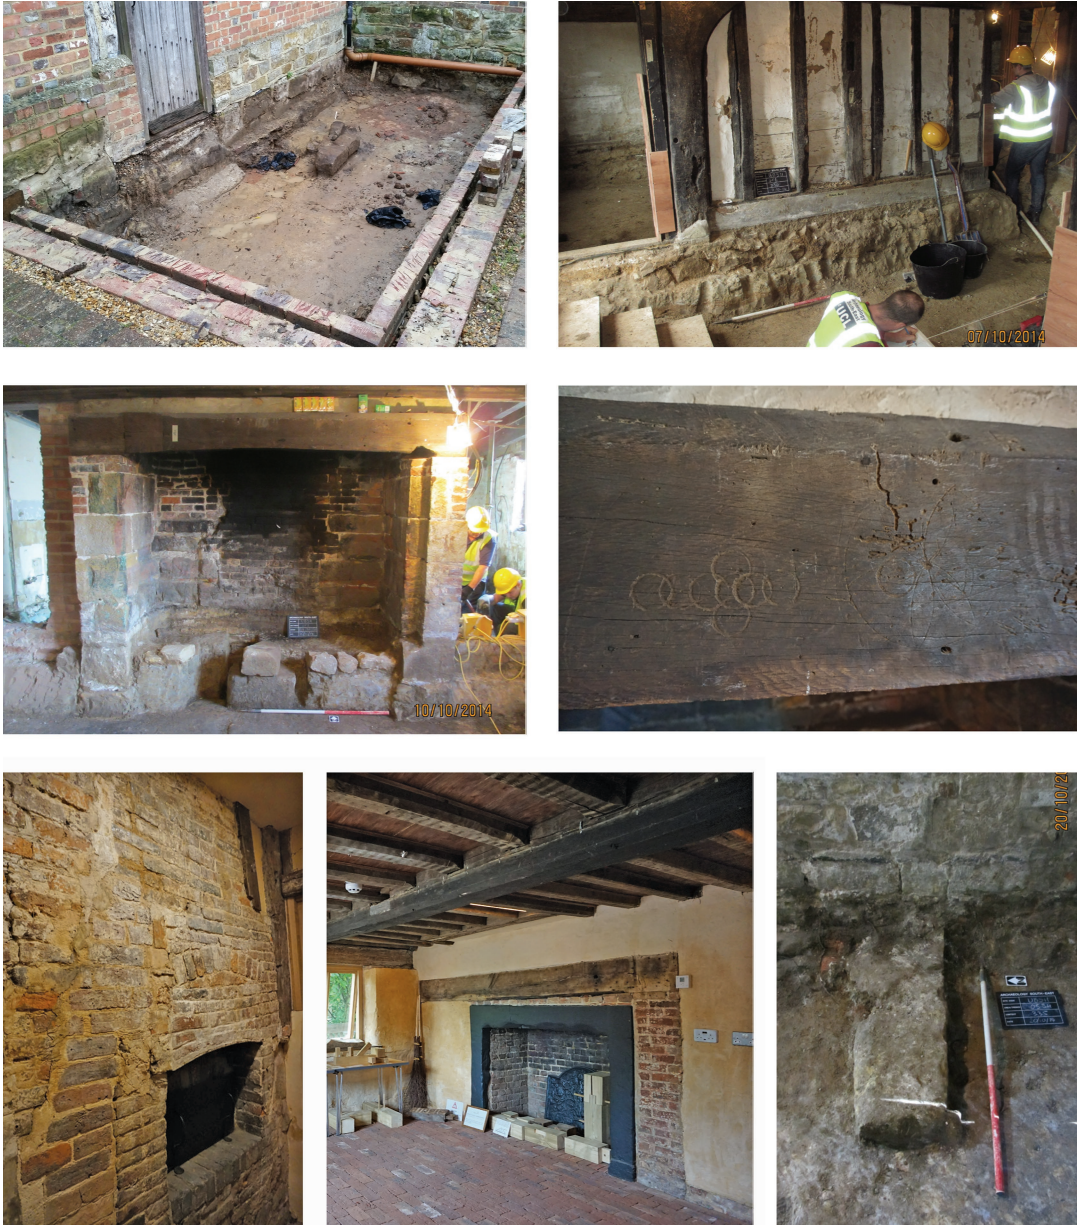
Fig. 20. Photos, Period 4. Top left: yard area with G32 in background; top right: G24 facing south; centre left: G26 fireplace looking north; centre right: witch marks on G26 lintel; bottom left: oven inserted into rear of kitchen fireplace; bottom centre: kitchen fireplace; bottom right: G28 buttress.

Modifications to the hall comprised the insertion of a brick chimneystack and fireplace (G26; Figs 18 and 20). The hall's ground floor was also resurfaced utilising a light grey-brown silt clay. Slabs of reused Horsham Stone found within the deposit may indicate that at least some of the hall's floor was flagged.

The fireplace for this chimney was deeper and wider than the example in the hall to the north, reflecting its use as a cooking hearth. A large stone block (G28; Figs 18 and 20), found in the area to

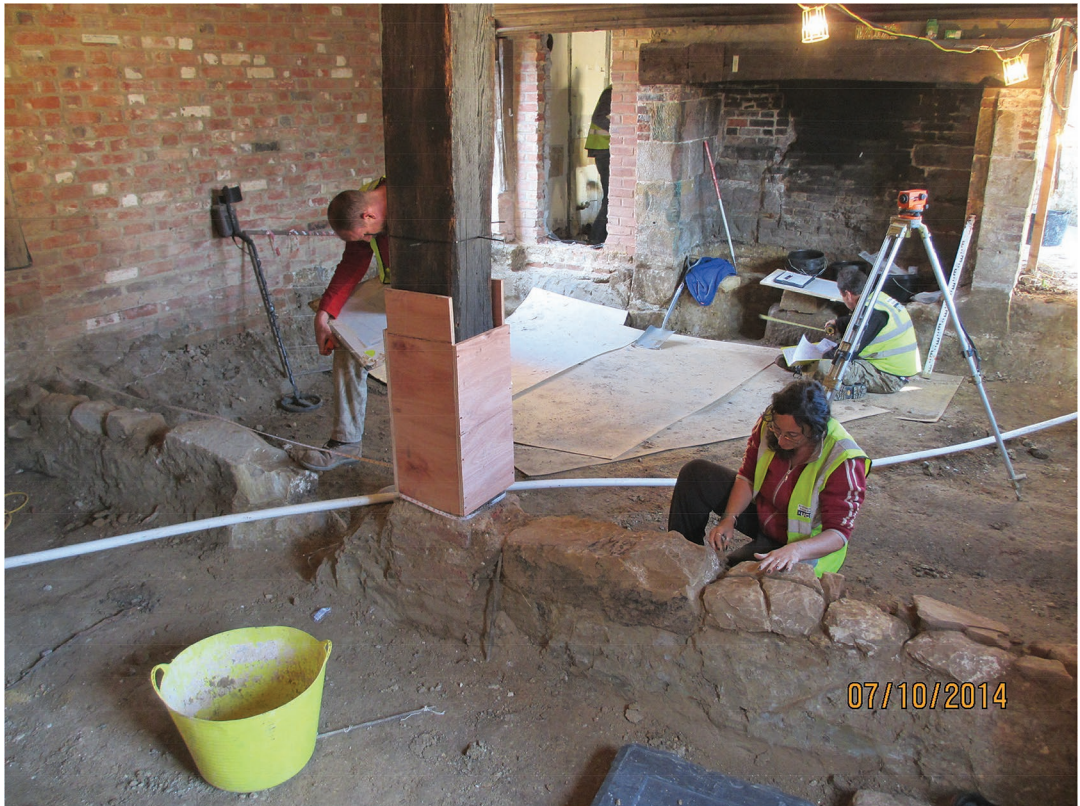
Fig. 21. G24 showing scorched stones (right of pillar), part of reredos screen.

The central foundation of the partition (G24) was formed of larger stone blocks than the remainder, and these showed signs of scorching on the southern side (Fig. 21). The blocks and the pattern of sooting apparent within the roof indicate the outer hall was served by a hearth.

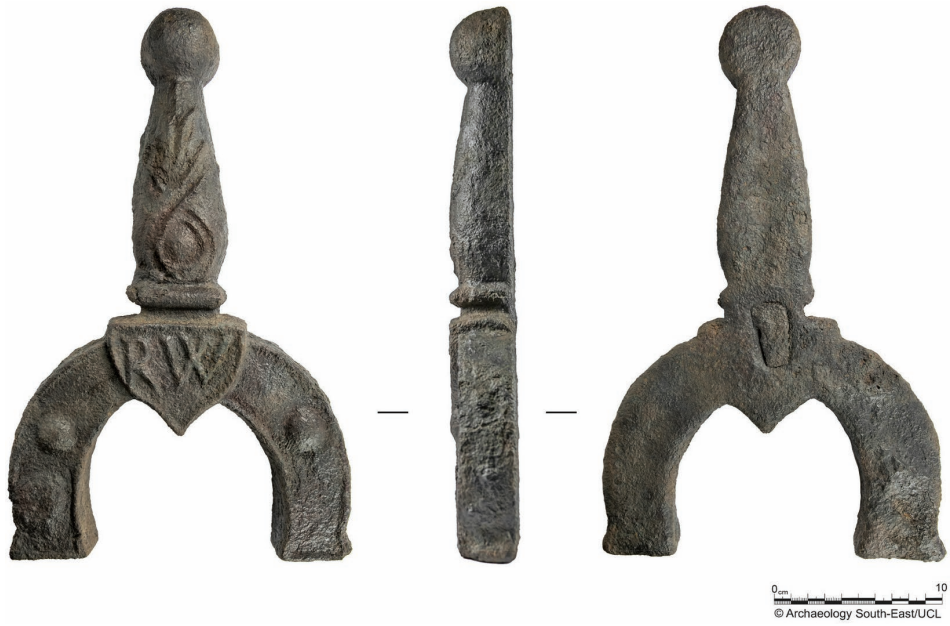
Fig. 22. Photo of cast iron firedog RF<1> (Archaeology South-East).

It may represent debris from a cleaned out fireplace used to level the room. Amongst the charcoal, part of a cast iron fire-dog (RF <1>; Fig. 22)

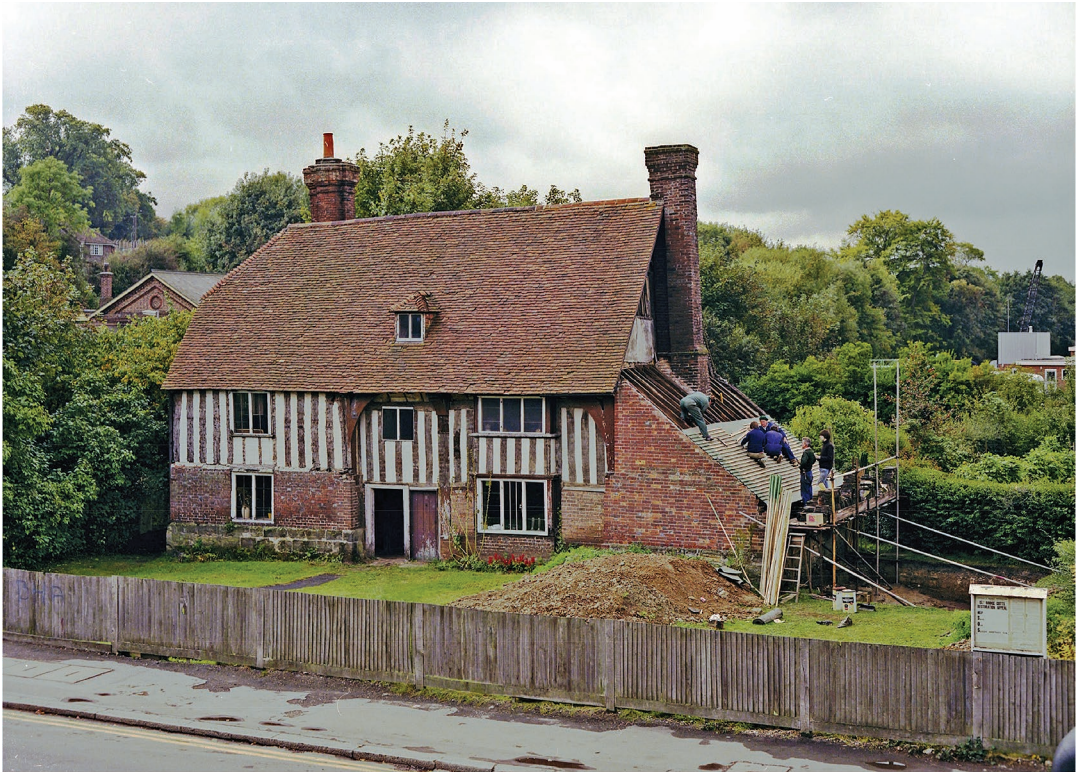
Fig. 24. Photo of Bridge Cottage prior to its renovation, showing how the building would have largely appeared in the early 18th century.

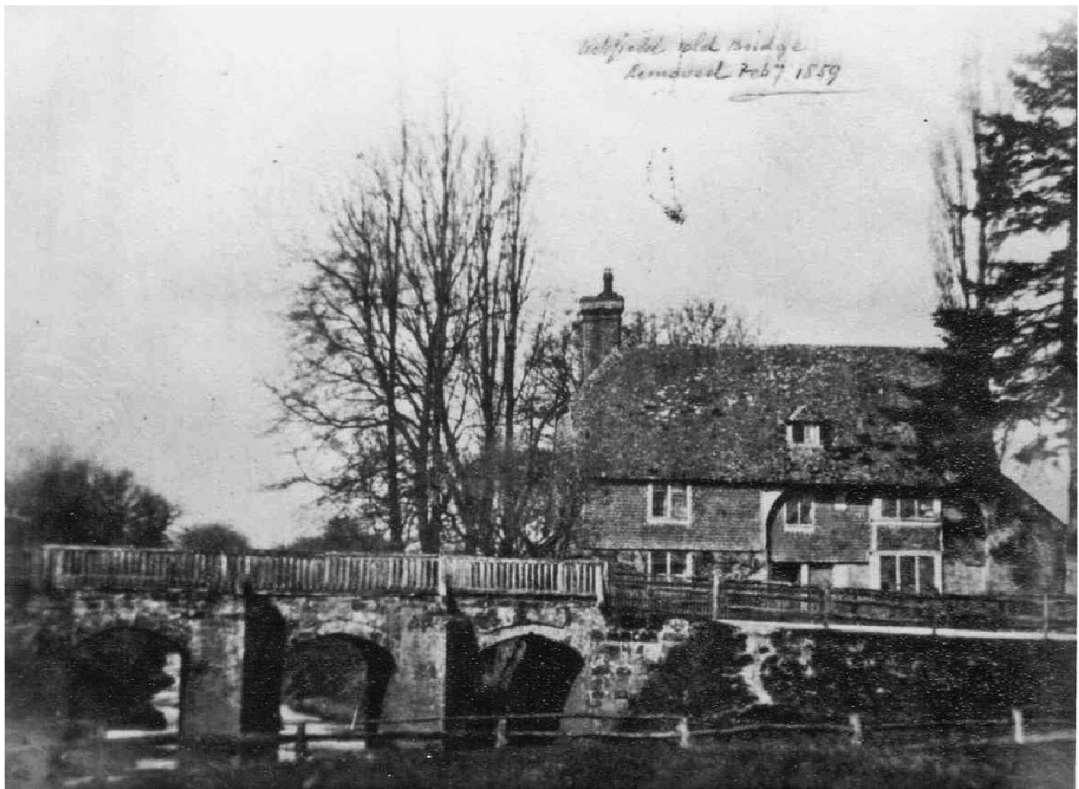
Fig. 25. Photo of Bridge Cottage in the 19th century prior to removal of the 'old bridge' (courtesy of Brian Philips and Mick Harker).

When the water met the old bridge (Fig. 25) that neighboured Bridge Cottage it swept away the parapet as well as several bystanders who had gathered to watch the flood (Turner 1860, 2). The drowning of these unfortunate people is symptomatic of the precarious nature of life, for both humans and buildings, on the banks of the River Uck.
